7. CASE EXERCISES

7.1 Case Example (Placer Dome, 2003)

7.2 Case Study

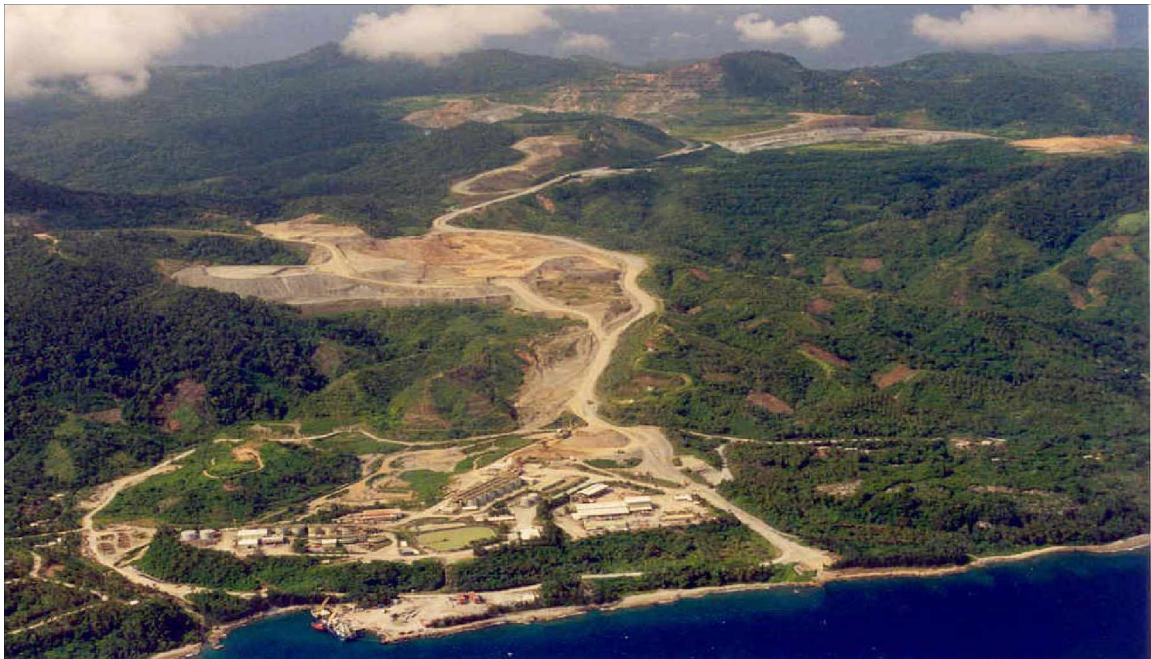
Figure 7.2: Aerial Photograph of the Misima Mine Plant Site.

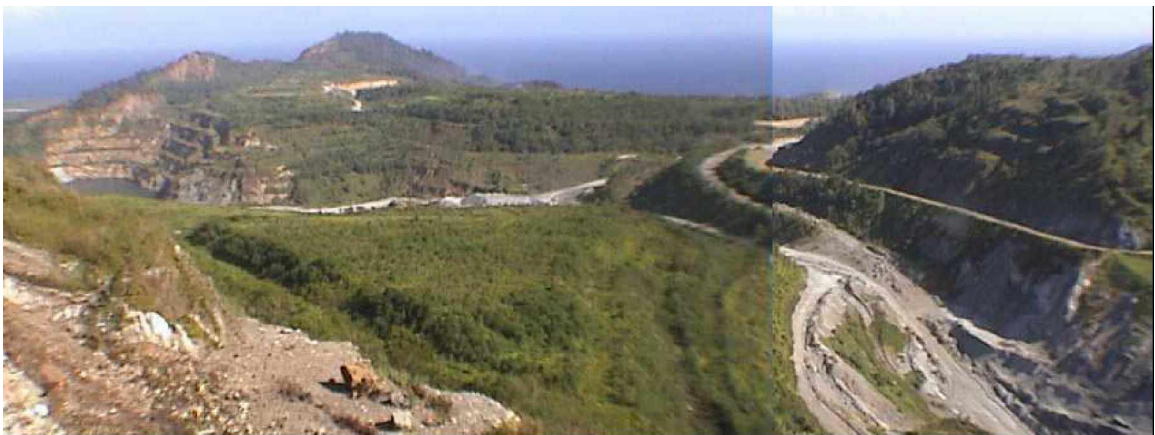
Figure 7.4: View from Mt. Sisa Showing Revegetated Pits and Dumps.

Open pit mining operations ceased in May 2001. Pit Closure began at the time mining operations ended and involves revegetation of open pits, waste rock dumps, and haul roads, as well as the sale and removal of the majority of the mobile earth moving equipment. Pit Closure is expected to take about 3 to 4 years to complete, although the majority of work in terms of landscaping and first-phase revegetation has already been completed.

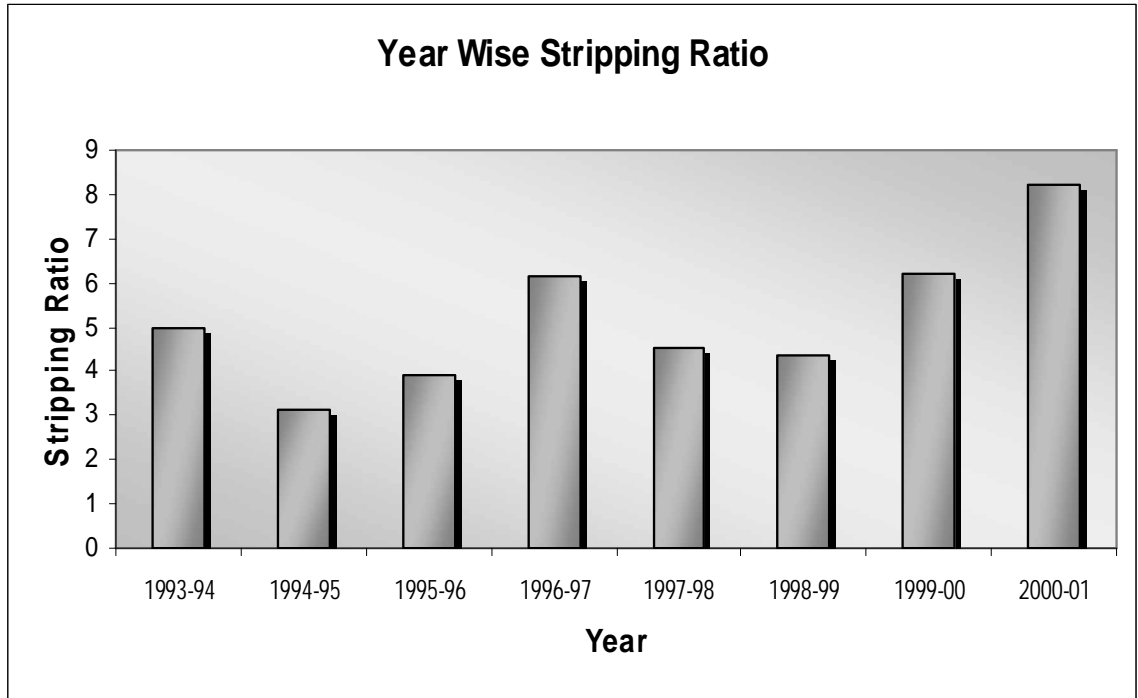
Figure 7.5: Year Wise Stripping Ratio of the Chora Mine.

- § Stripping ratio was increased as working was extended. In the year 1993-94, stripping ratio was 4.98 and in 2000-01, stripping ratio was reached to a value of 8.19. So it was not possible to continue the working with such high stripping ratio.
- § The working was progressed towards the Regional Hospital, Chora and the Main Road for transportation.
